**TECHNICAL REPORT  
NATICK/TR-95/026**

# **VENTILATION SYSTEM FOR THE MOBILE KITCHEN TRAILER**

**FINAL REPORT  
November 1991 - September 1994**

**U.S. ARMY SOLDIER SYSTEMS COMMAND  
NATICK RESEARCH, DEVELOPMENT AND ENGINEERING CENTER  
NATICK, MASSACHUSETTS 01760-5018**

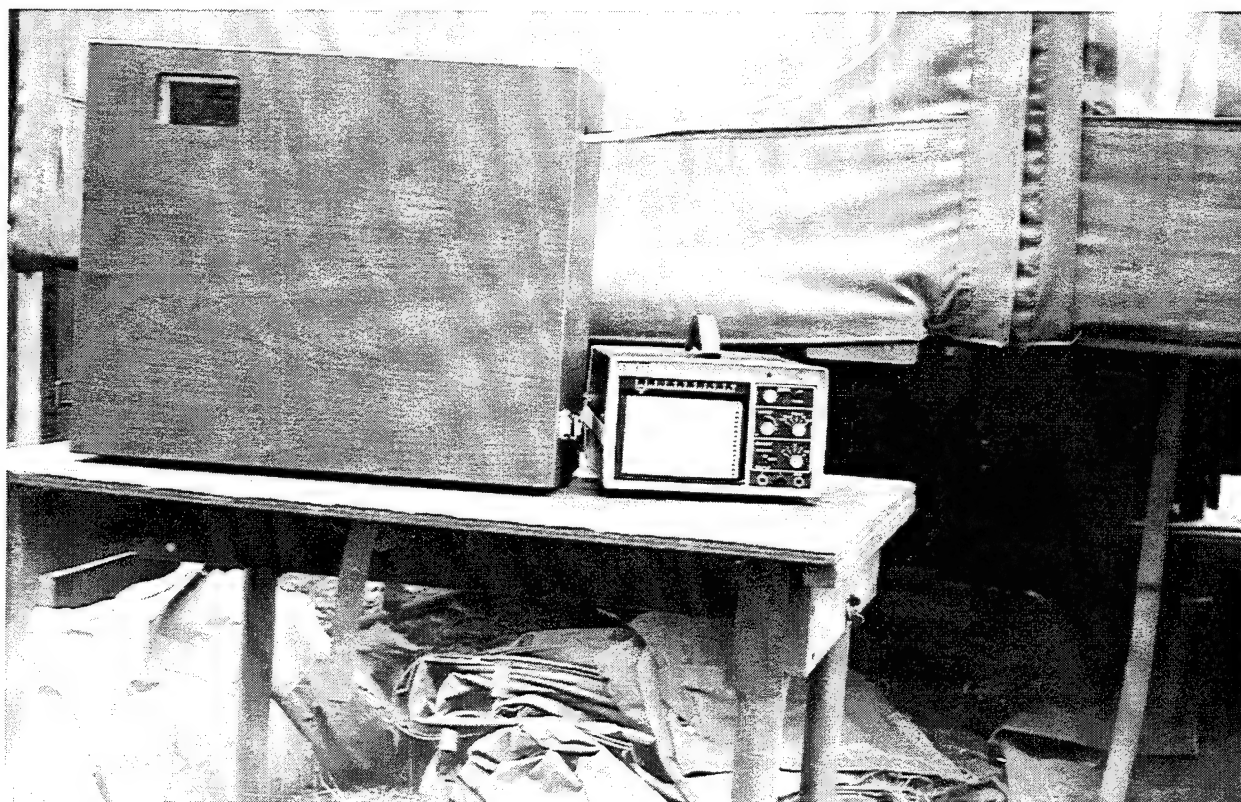
The formaldehyde concentrations within the MKT were measured by the TGM 555 monitor. The TGM 555 monitors digital readouts are not parts per million, but a percentage of the calibrated scale. The range of the scale for the TGM 555 monitor for these tests was set at 0 to 0.5 ppm of formaldehyde. The TGM 555 monitor was placed outside the MKT, with a 15 ft. sample hose extending into the MKT. Placing the TGM 555 monitor outside of the MKT prevented the monitor from being affected by high temperatures inside the MKT. The TGM 555 sampling hose was placed in the center of the MKT, five feet above the floor to record the formaldehyde readings. The data was logged continuously with the LINEAR Chart Recorder. When the testing was completed, the data points were taken from the chart at 2 minute intervals and entered in a Quattro Pro file. Quattro Pro was used to convert the percentages to parts per million of formaldehyde and develop the graphs to compare vent versus nonvent results. A picture of the TGM 555 monitor and the LINEAR chart recorder is shown in Figure 23.

Figure 23. TGM 555 monitor and LINEAR chart recorder used for testing formaldehyde.

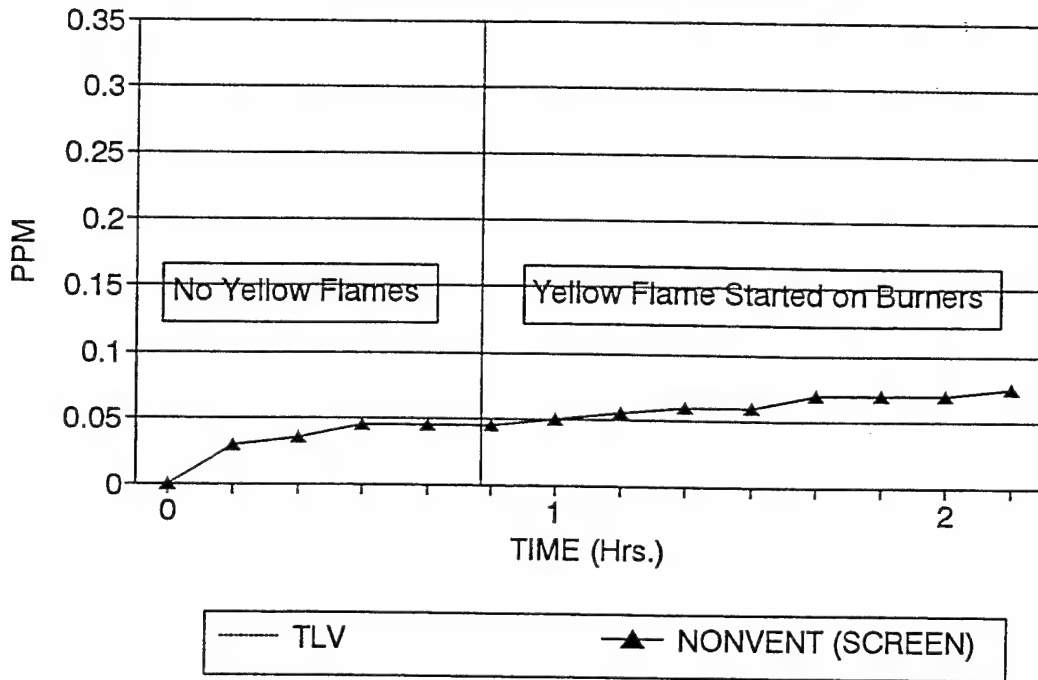
Figure 24. Formaldehyde concentrations within the Mobile Kitchen Trailer when using FIVE M-2 burners, and SCREEN SIDES in the nonvent configuration, at an ambient temperature of 53°F. After 45 minutes the M-2 burners were set to produces a yellow flame to create a worst case condition inside the Mobile Kitchen Trailer when using screen sides. (Note: TLV represents the Threshold Limit Value for formaldehyde and the precision of the data is + or - 0.01 ppm.)

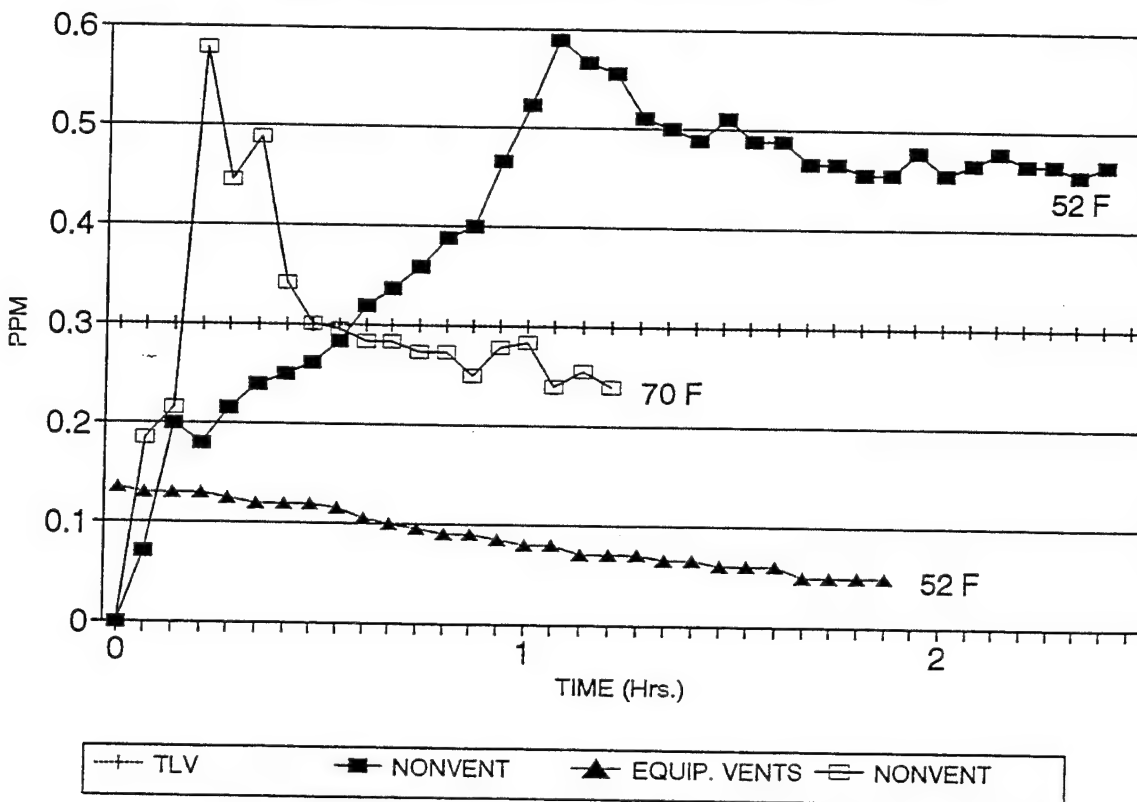
As expected, formaldehyde concentrations in the MKT were much higher when tested with the MKT canvas sides installed. Figure 25 shows the concentration of formaldehyde within the MKT with canvas sides, three M-2 burners and with and without vents. In the nonvent configuration the concentration of formaldehyde stabilized near or above the TLV for formaldehyde. However, with the equipment vents installed the formaldehyde concentration was reduced to approximately 0.05 ppm. In Figure 25 the data for the equipment vents begins at approximately 0.13 ppm because the equipment vents were installed immediately after the test for the nonvent configuration was completed. The MKT was opened while the equipment vents were installed, but the concentration of formaldehyde and the TGM 555 monitor did not completely zero before the test for the equipment vents was initiated.

Figure 25. Formaldehyde concentrations within the Mobile Kitchen Trailer when using three M-2 burners in the nonvent and equipment vented configuration at ambient temperatures of 52°F and 70°F. (Note: TLV is the Threshold Limit Value for formaldehyde and the precision of the data is + of - 0.01 ppm.)

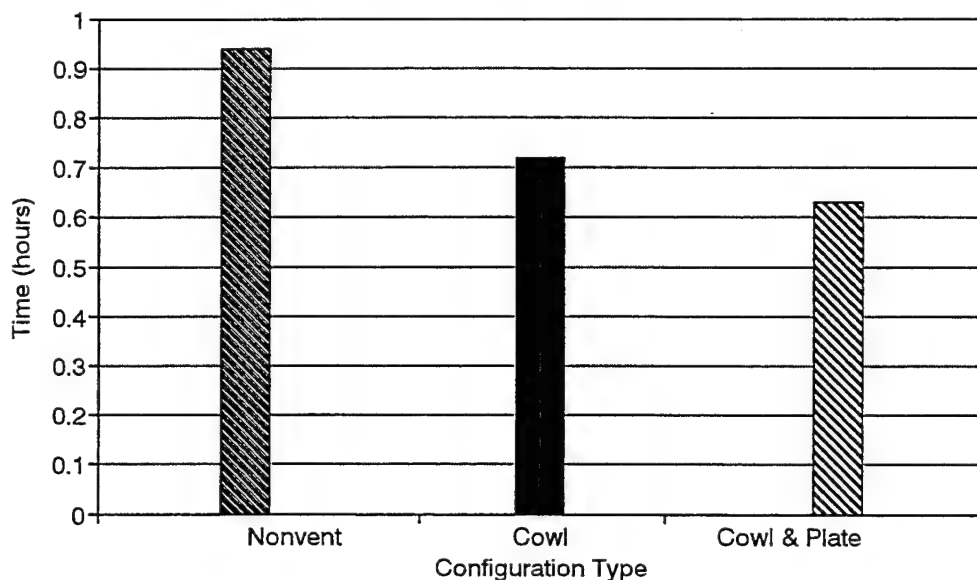
## HEATING TIMES FOR WATER ON GRILL

When Using the M-2 Burner

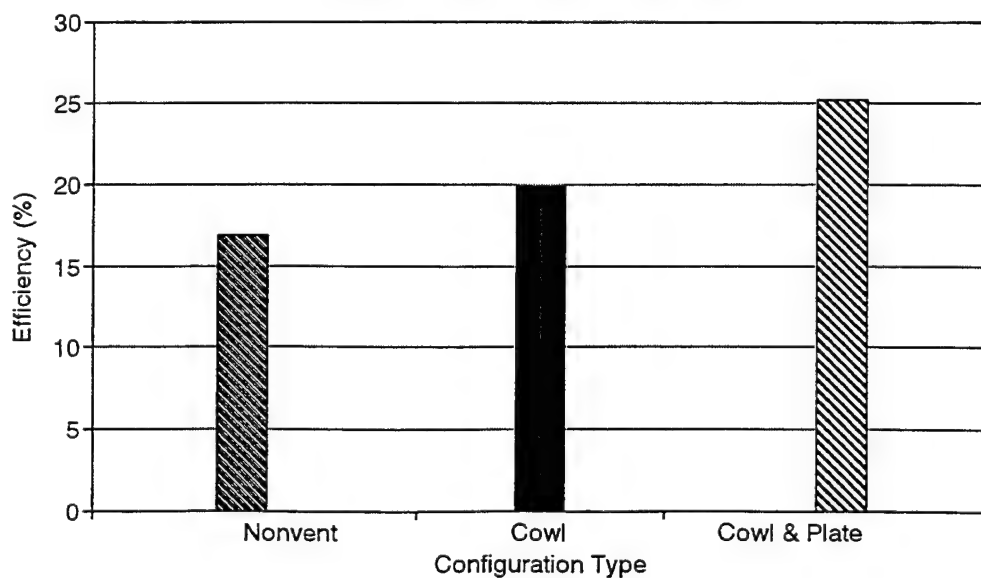
Figure 27. Time and efficiency to heat 100 lbs. of water 130°F on the grill in three different configurations without boiling the water during heating.

The efficiency of the grill was calculated by dividing the energy output by the energy input. The energy output consisted of the temperature change of water (130°F) multiplied by the weight of the water heated. The input consisted of the heat of combustion of the fuel multiplied by the weight of the fuel burned. The Heat of Combustion for gasoline is 20,000 Btu/lb. The Heat of Combustion for diesel is 19,500 Btu/lb. The formula and a sample calculation are shown below.

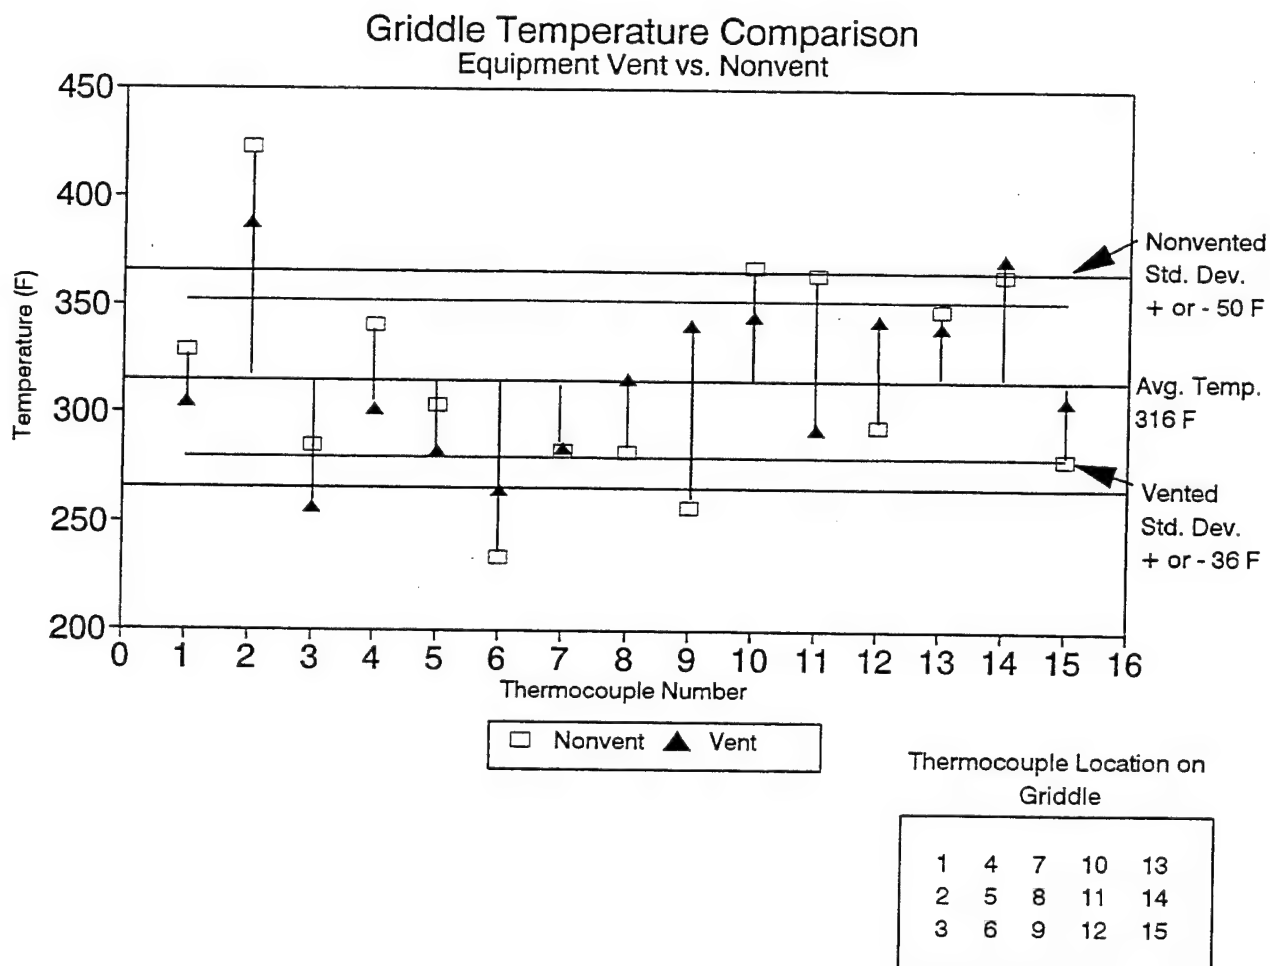
Figure 28. Griddle temperature comparison when using two M-3 burners under the griddle in the nonvent and equipment vented configurations.

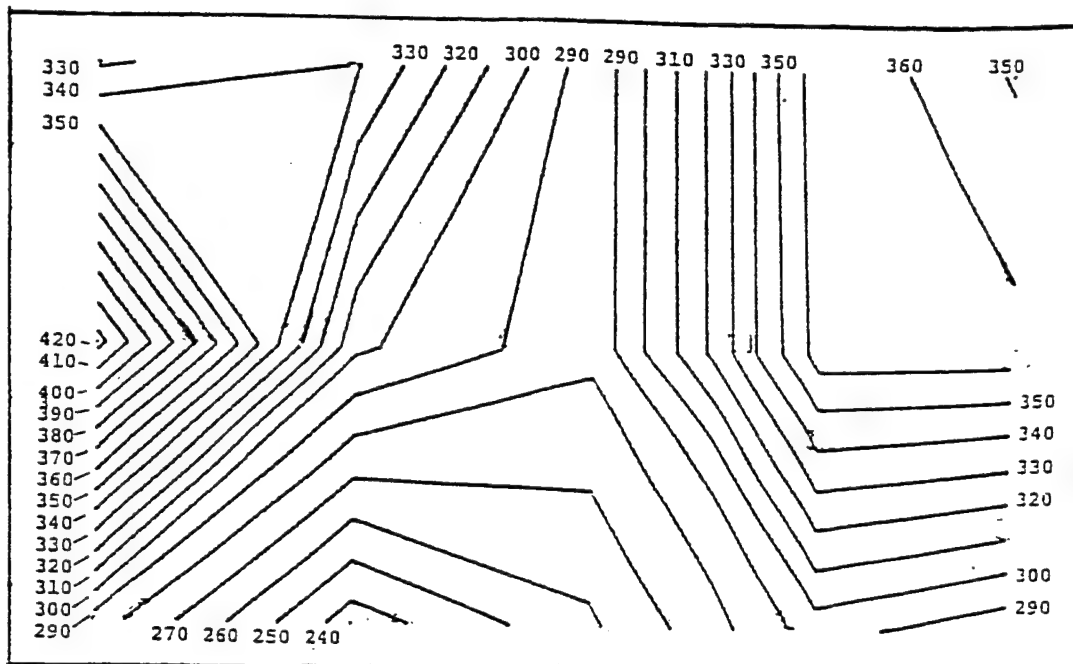
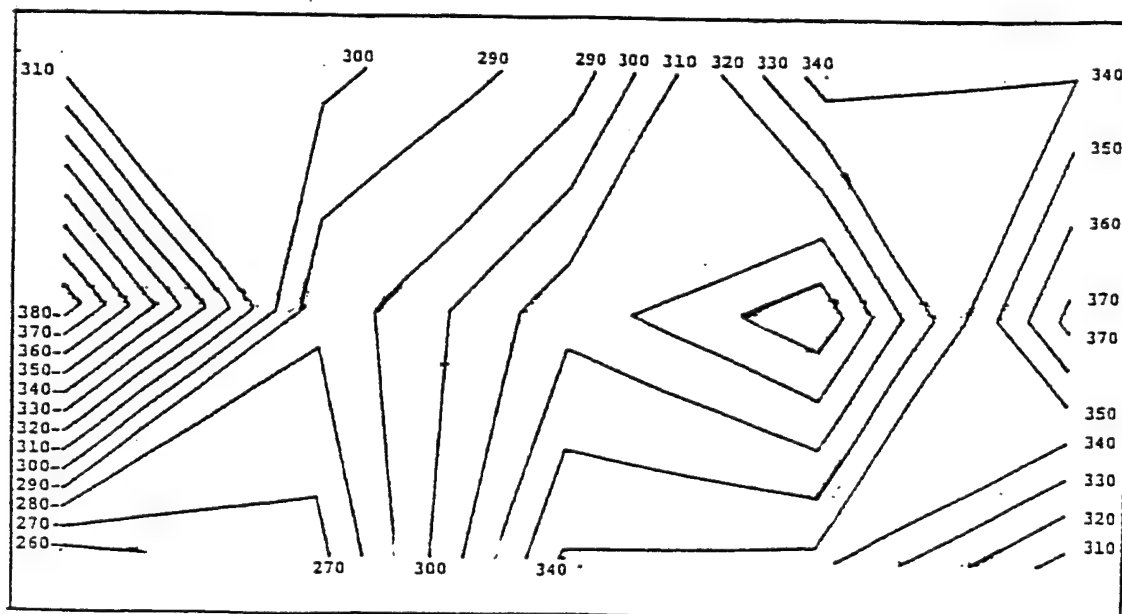
Figure 29. Griddle contour temperature plots for the nonvent and equipment vented configuration.

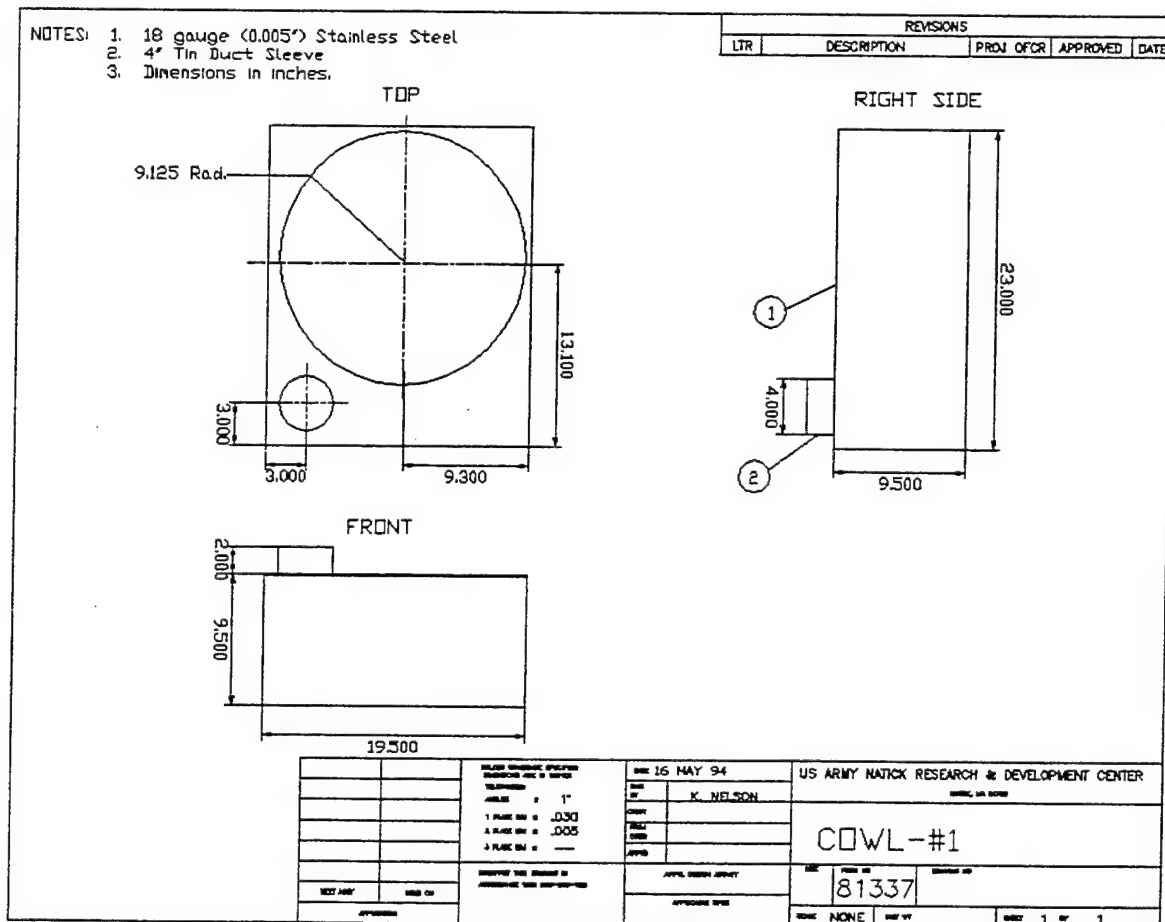
Figure A-2: Drawing plan for the first equipment vent for the Grill.

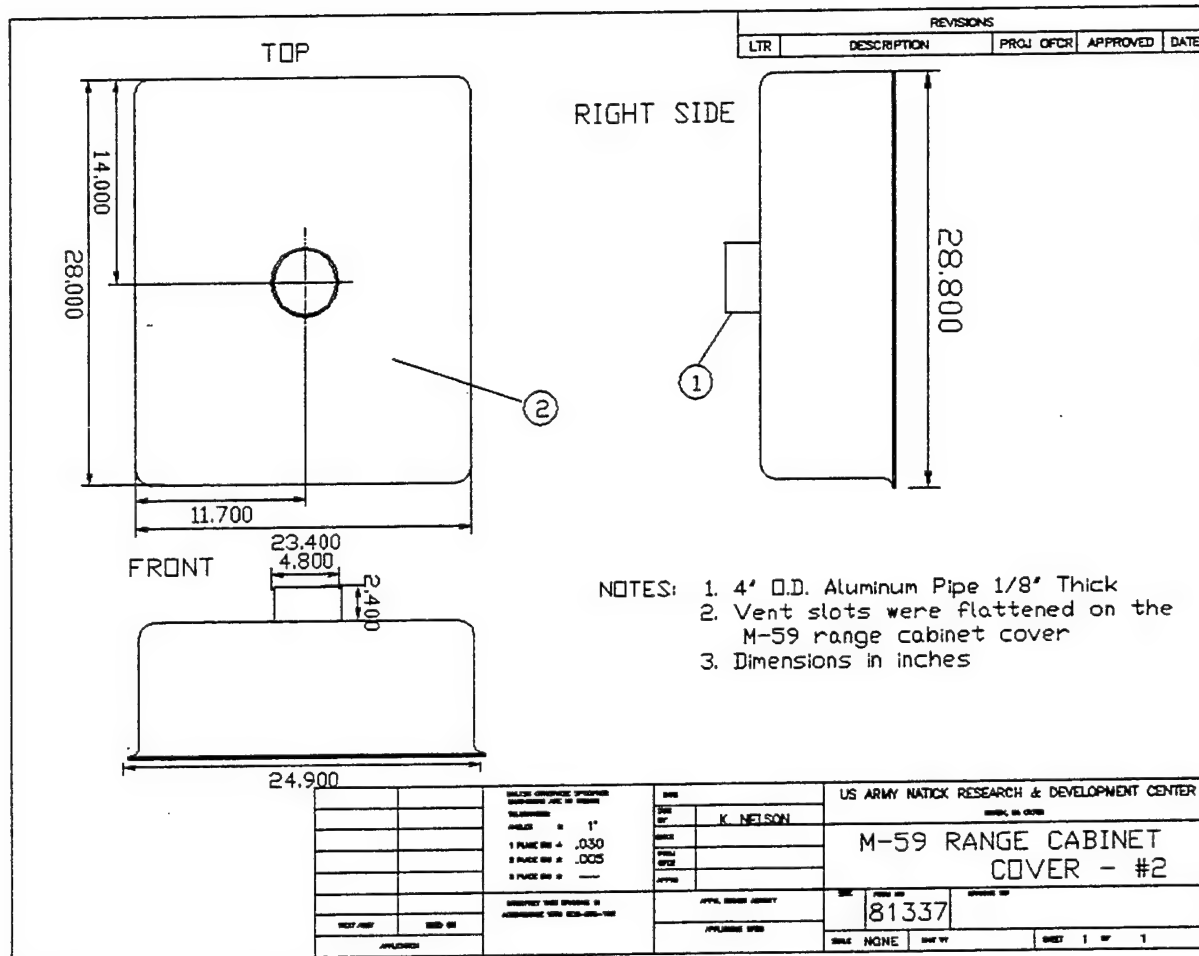
Figure A-6. Drawing of the M-59 Range Cabinet with vent slots closed and 4 inch aluminum pipe added to vent combustion gases.

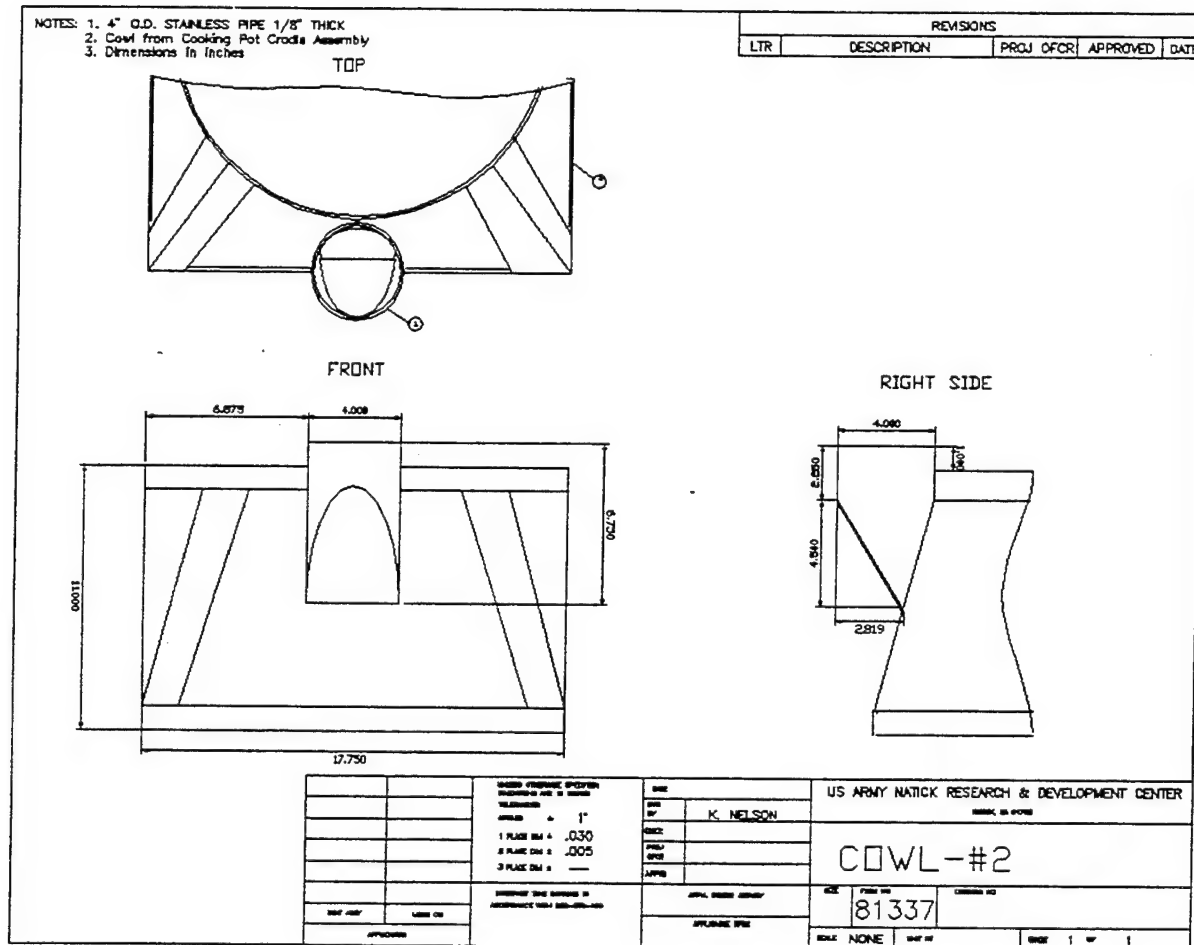
Figure A-7. Drawing plan for the second equipment vent for the Grill.

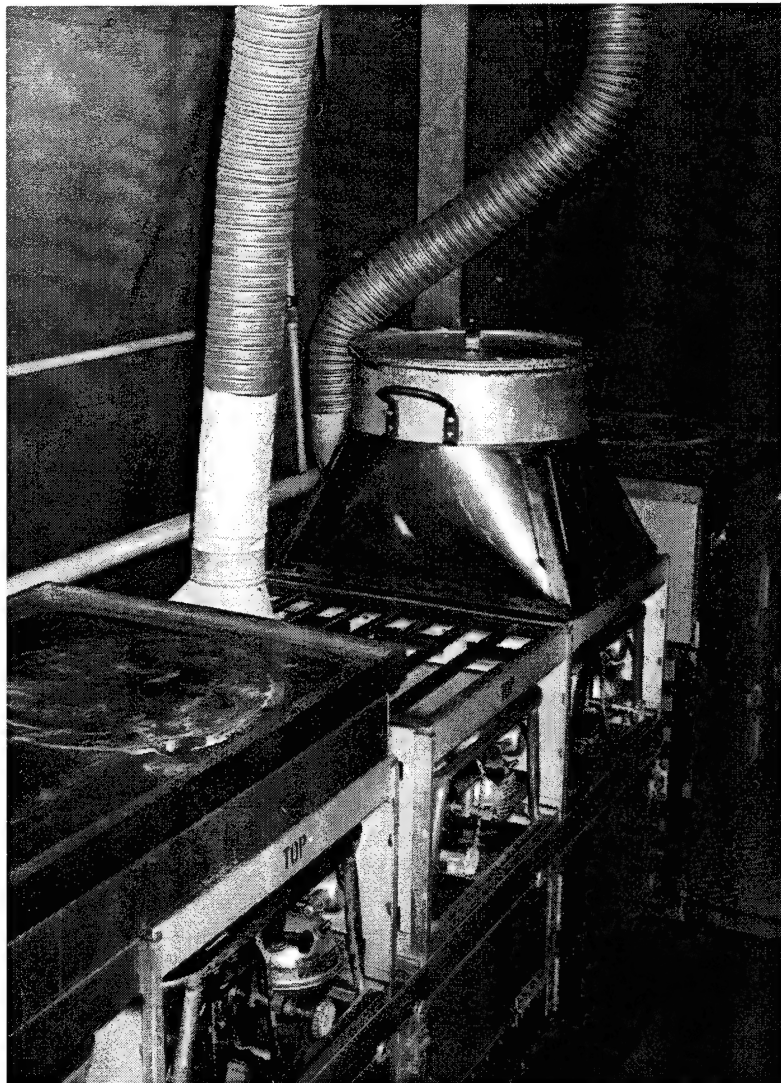
For the stacks, 4-inch i.d. flexible tubes, able to withstand temperatures up to 600°F were purchased. The flexible tubes were cut to fit between each equipment vent and the chimney collar. A picture of the flexible tubes is shown in Figure A-8.

Figure A-8. Flexible tubes used for stacks with the second set of equipment vents.

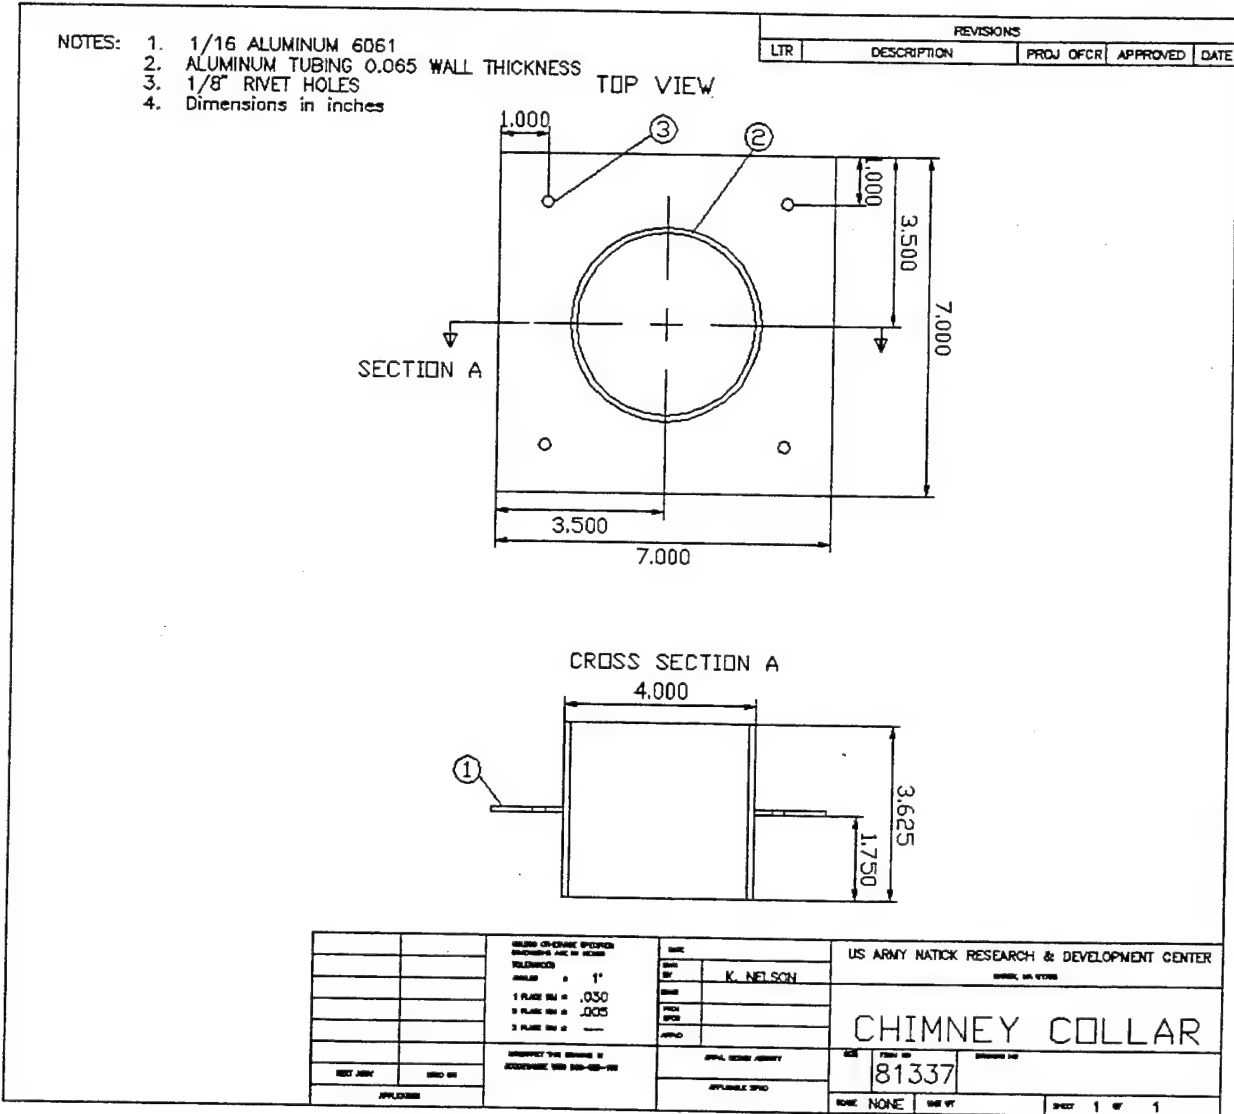
Figure A-9. Drawing plan for the Chimney collar designed to connect the chimney and flexible stack for the second set of equipment vents in the Mobile Kitchen Trailer.

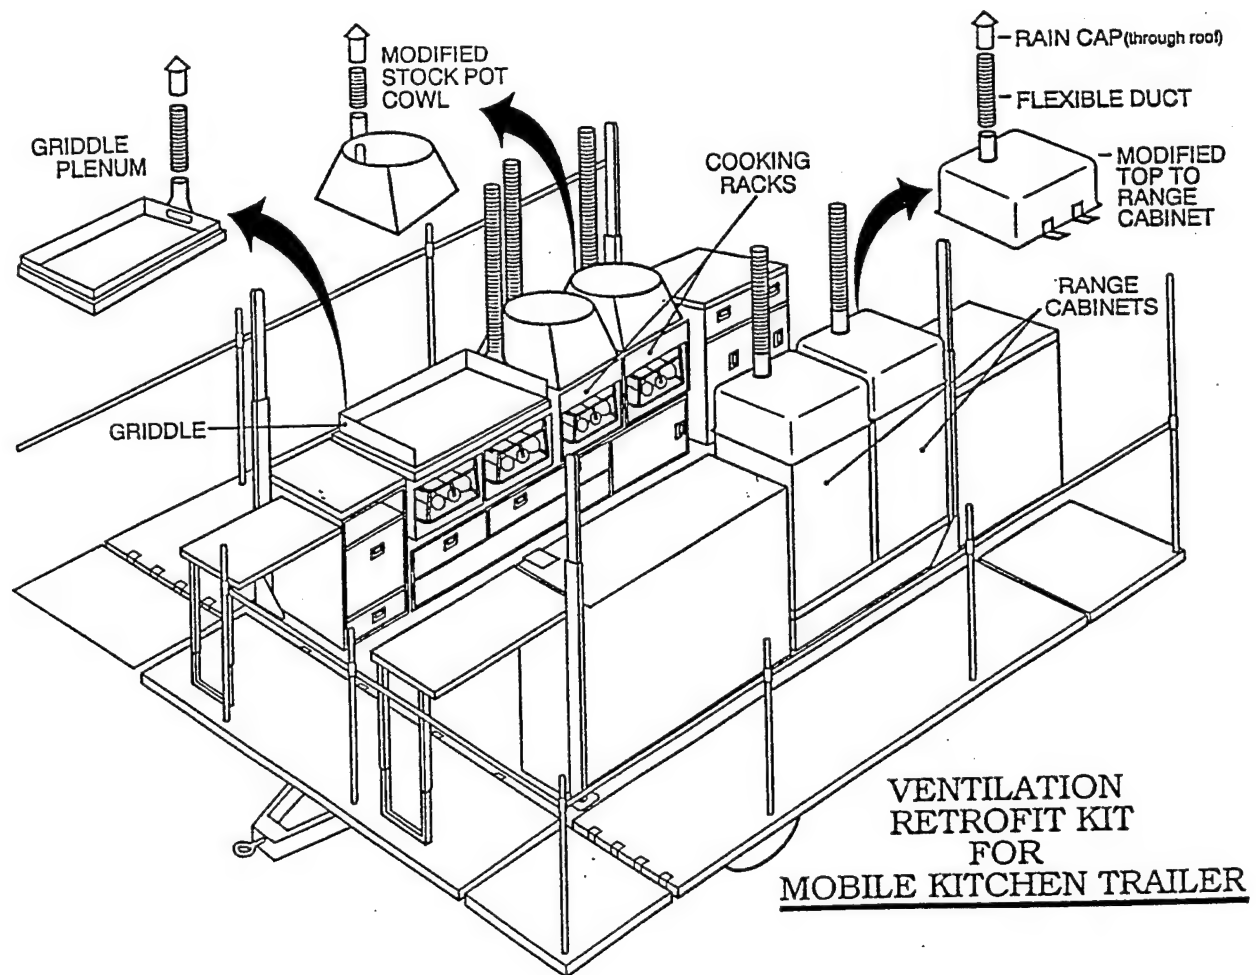
The roof of the MKT supported 2 ft. sections of 4-inch diameter galvanized stove-pipe fitted with a rain-cap, that was slid over the chimney collars. In transit the stove-pipe and rain-cap would be replaced by a vent cap. The 4-inch stove-pipe and the rain-cap would be stowed inside the MKT. Figure A-10 shows the location of the equipment vents within the MKT.

Figure A-10. Perspective view of the ventilation system within the Mobile Kitchen Trailer.

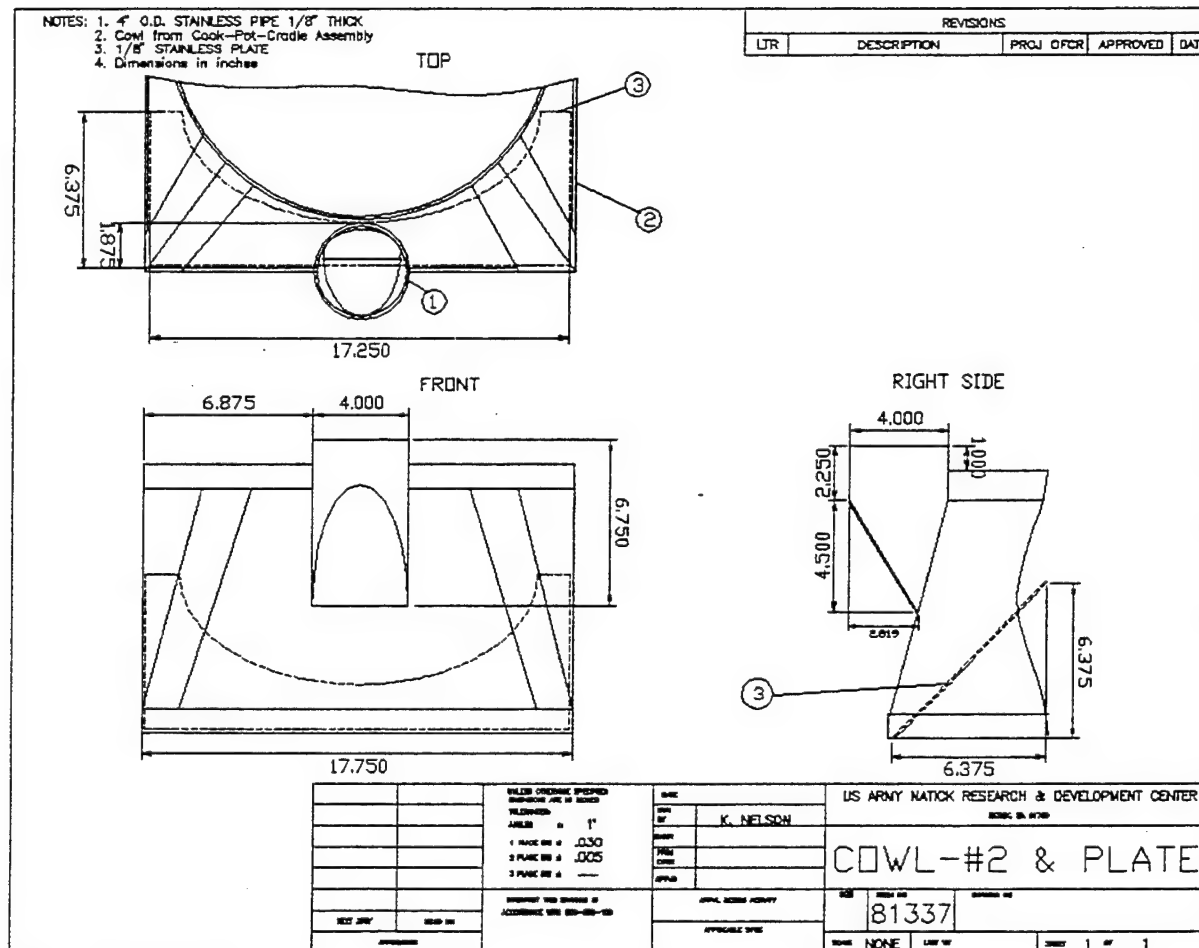
Figure A-11. Drawing plan for Cowl-#2 with half-moon plate added for improved performance of the Grill.

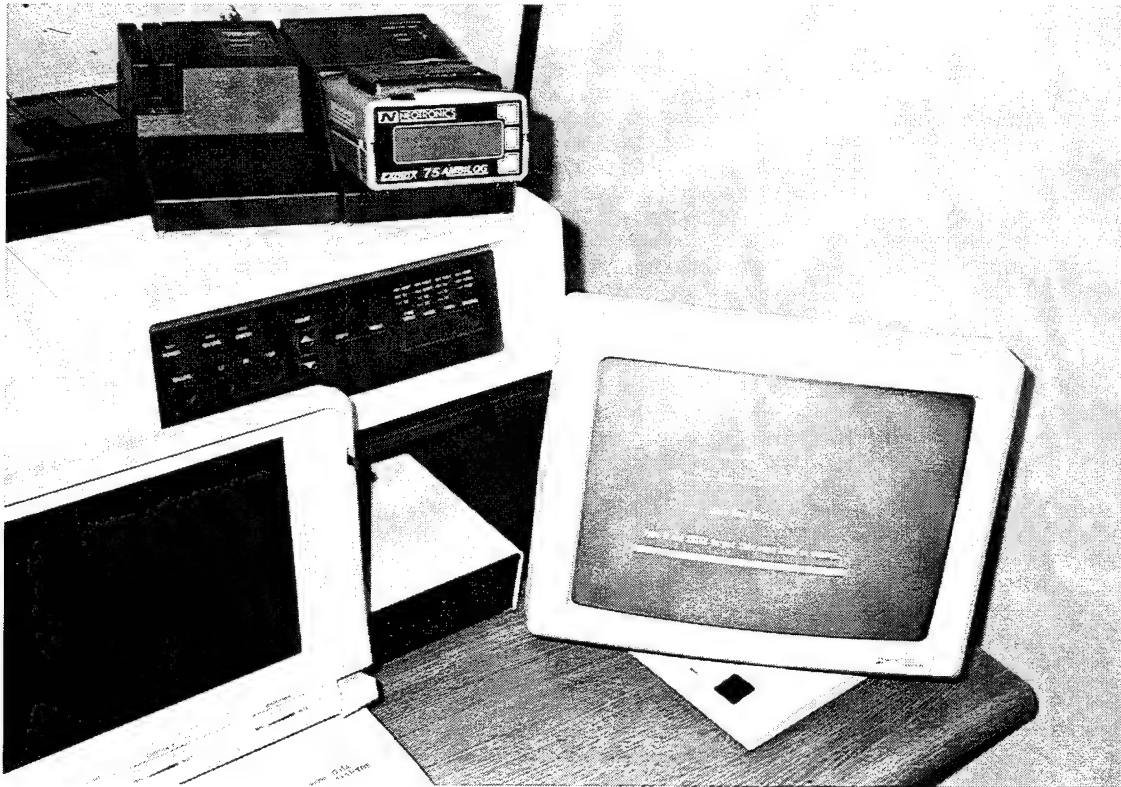
Figure B-1. Exotox 75 Gas Monitor and the System Data Interface for downloading data to the computer.

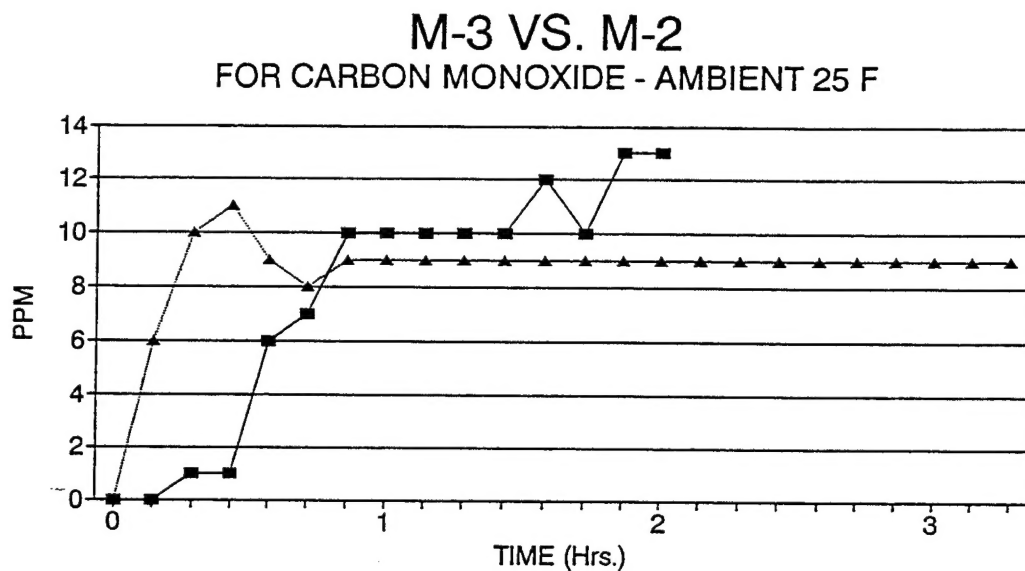
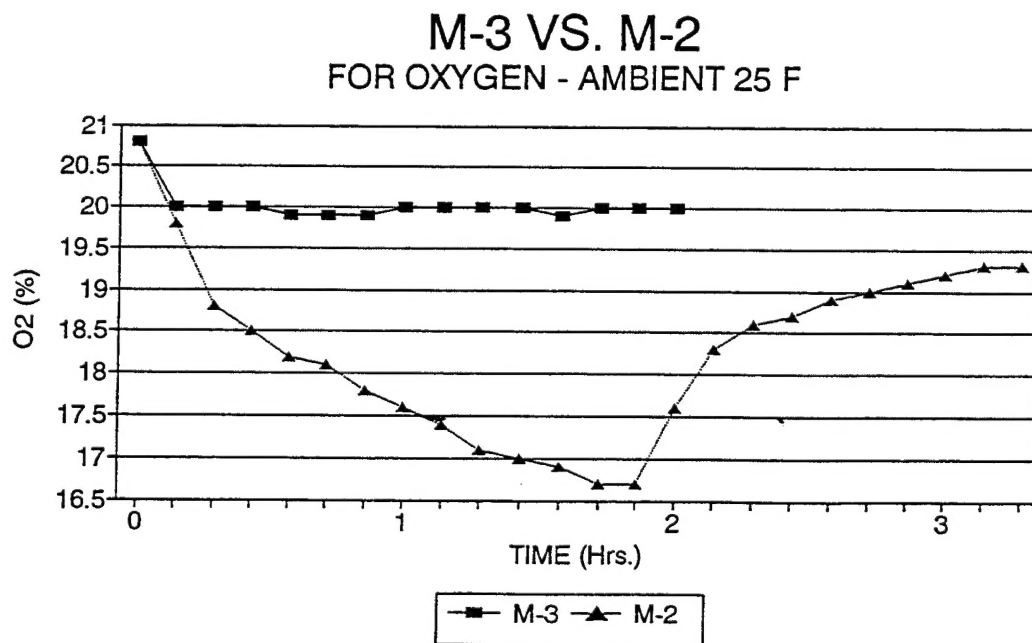
Figure C-1. M-3 versus M-2 burners for carbon monoxide and oxygen concentrations in the Mobile Kitchen Trailer in the nonvent configuration at an ambient temperature of 25°F.

In the comparison of the M-2 and M-3 burners, the results show a slight advantage of the M-3 burner in the percent oxygen within the MKT. The carbon monoxide concentrations are similar. However, Figures C-1 and C-2 do not provide a thorough analysis for comparing the two burners. Other gases such as formaldehyde, toluene and benzene would need to be tested to draw a final conclusion.

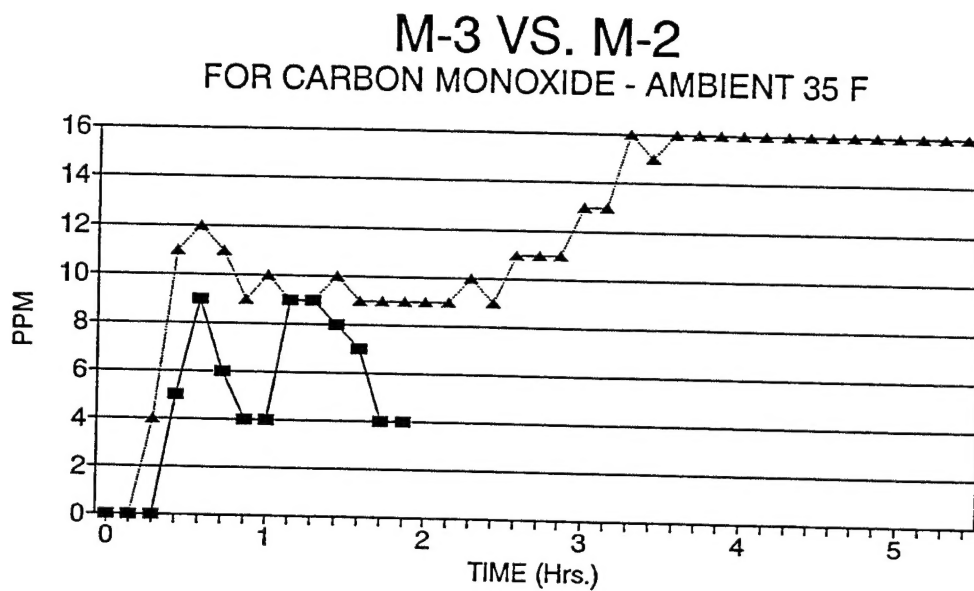
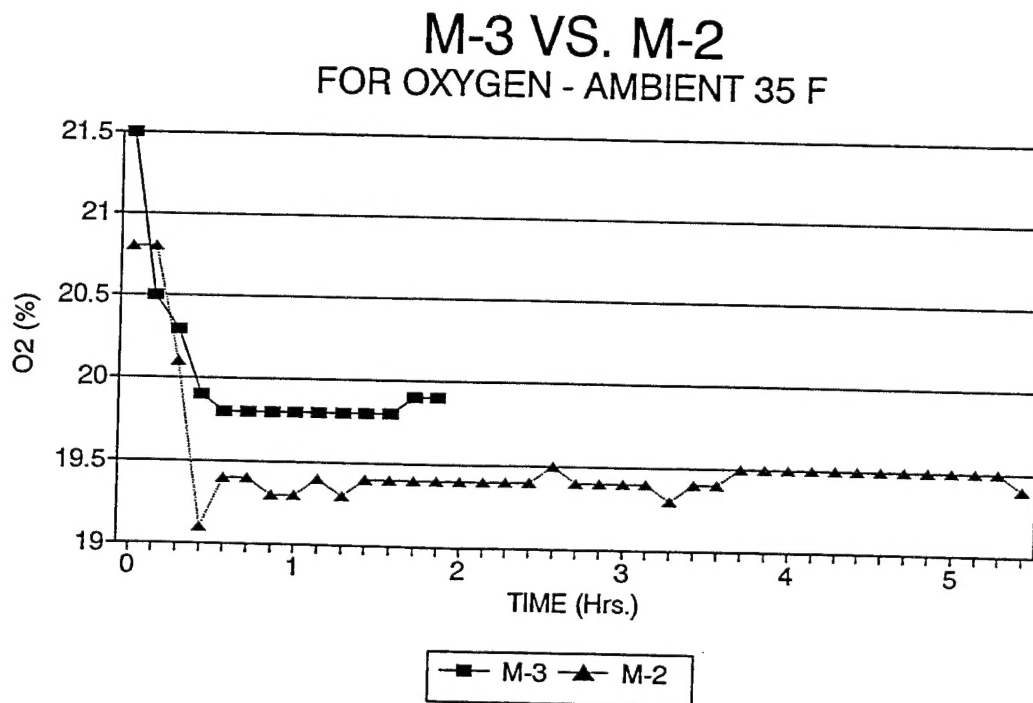
Figure C-2. M-3 versus M-2 burners for carbon monoxide and oxygen concentrations in the Mobile Kitchen Trailer in the nonvent configuration at an ambient temperature of 35°F.
